Barrette Structural Inc.

TYPICAL REPAIR METHOD FOR A NOTCHED 2X4 TOP CHORD, WITHOUT CUTTING THE OSB PANEL

RTF-009-18

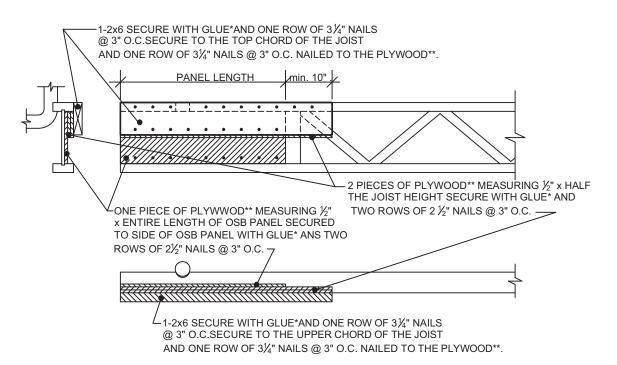
SITUATION BEFORE REPAIR

SITUATION AFTER REPAIR

*PL PREMIUM GLUE ** Plywood - at least $\frac{1}{2}$ " 4 ply ($\frac{15}{32}$ ") or better
