P3 BY EACOM
 TYPICAL REPAIR DETAILS

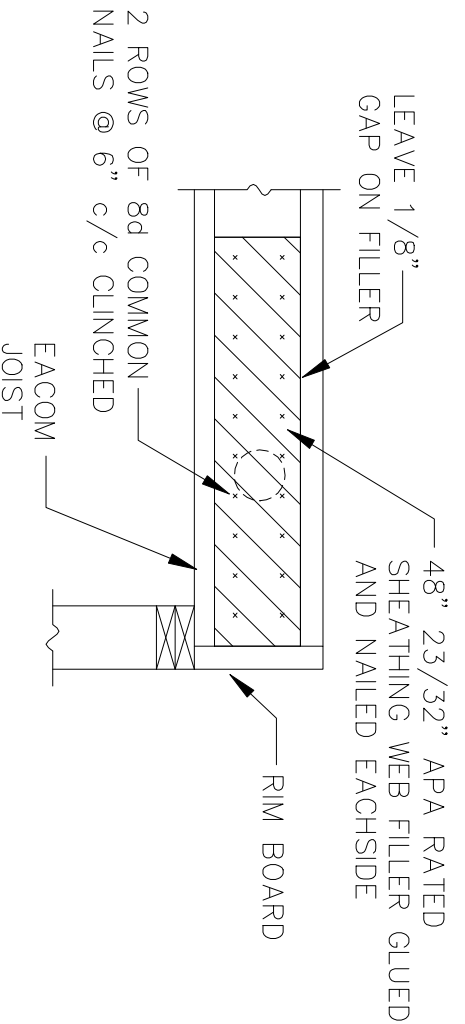
REPAIR DETAIL FOR HOLE IN WEB NEAR BEARING

NOTE:
 DAMAGE TO I-JOIST FLANGE AND/OR WEB CAN CAUSE FAILURE OF FLOOR SYSTEM. SPAN, SPACING AND LOADING AS WELL AS EXTENT AND LOCATION OF DAMAGE ALL AFFECT THE REPAIR REQUIRED.

ALL GLUED AND NAILED
