P3 BY EACOM
 TYPICAL REPAIR DETAILS

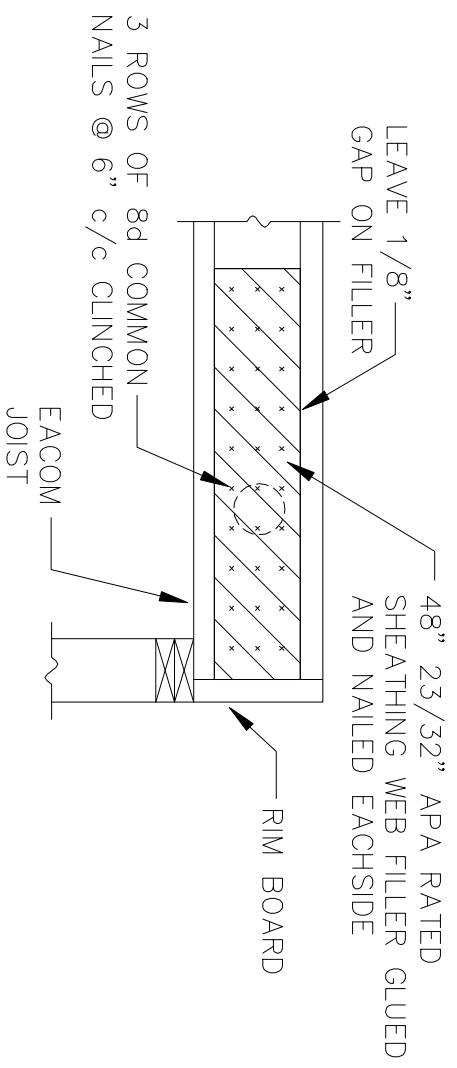
REPAIR DETAIL FOR HOLE IN WEB NEAR BEARING

NOTE:
 DAMAGE TO I-JOIST FLANGE AND/OR WEB CAN CAUSE FAILURE OF FLOOR SYSTEM. SPAN, SPACING AND LOADING AS WELL AS EXTENT AND LOCATION OF DAMAGE ALL AFFECT THE REPAIR REQUIRED.
 EACH CASE SHALL BE REVIEWED.

ALL GLUED AND NAILED
