REPAIR DETAIL FOR TOP
FLANGE NOTCH AT CENTER
SPAN OF JOISTS

TYPICAL REPAIR DETAIL "F"

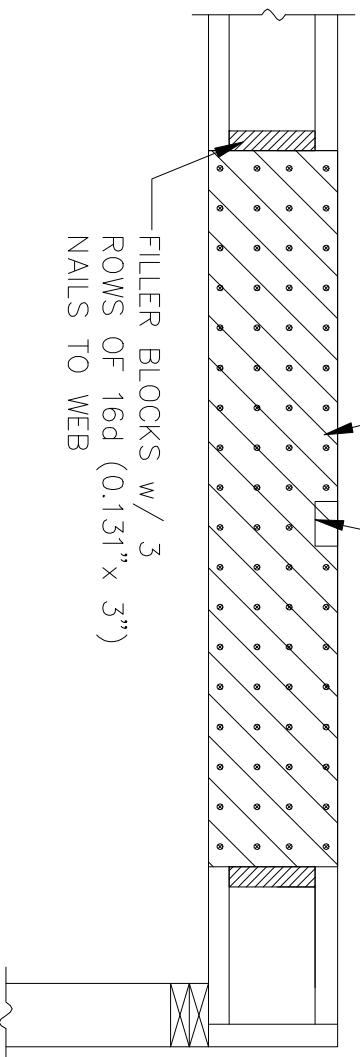
LARGE SIDE NOTCH IN TOP
FLANGE CENTER REPAIR AT
NOTCH LOCATION

NOTE:
DAMAGE TO I-JOIST FLANGE
AND/OR WEB CAN CAUSE
FAILURE OF FLOOR SYSTEM.
SPAN, SPACING AND LOADING AS
WELL AS EXTENT AND LOCATION
OF DAMAGE ALL AFFECT THE
REPAIR REQUIRED.
EACH CASE SHALL BE REVIEWED.

ATTACH 48" 1 1/8" APA RIM OR MIN.
1 1/4" LVL ON EITHER SIDE GLUED
AND NAILED w/ 16d SINKER @ 6" c/c
TO TOP AND BOTTOM FLANGES

FILLER BLOCKS w/ 3
ROWS OF 16d (0.131" x 3")
NAILS TO WEB

ALL GLUED AND NAILED
