TYPICAL REPAIR DETAIL "G-B"

P3 BY EACOM
 TYPICAL REPAIR DETAILS

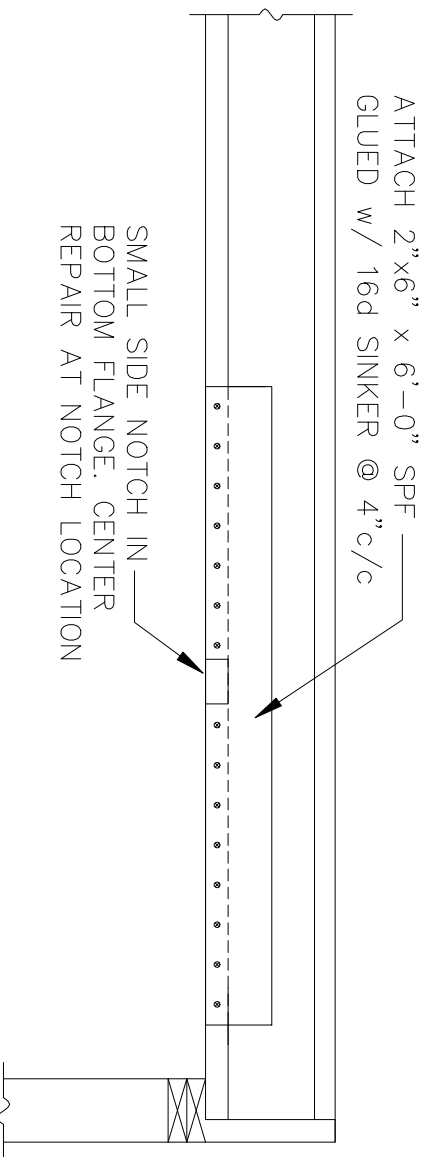
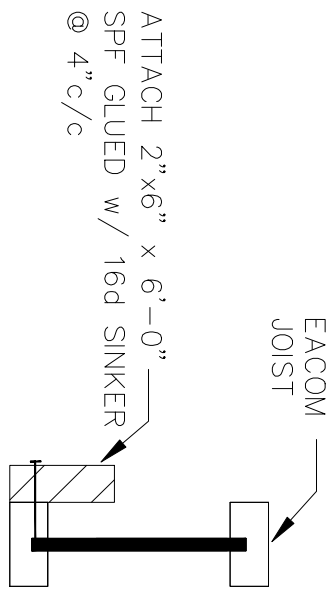
NOTE:
 DAMAGE TO I-JOIST FLANGE AND/OR WEB CAN CAUSE FAILURE OF FLOOR SYSTEM. SPAN, SPACING AND LOADING AS WELL AS EXTENT AND LOCATION OF DAMAGE ALL AFFECT THE REPAIR REQUIRED.
 EACH CASE SHALL BE REVIEWED.

ALL GLUED AND NAILED

REPAIR DETAIL FOR BOTTOM FLANGE NOTCH 4'-0" OR LESS FROM BEARING
