REPAIR DETAIL FOR CEILING
JOIST TAPER CUT

P3 BY EACOM
TYPICAL REPAIR DETAILS

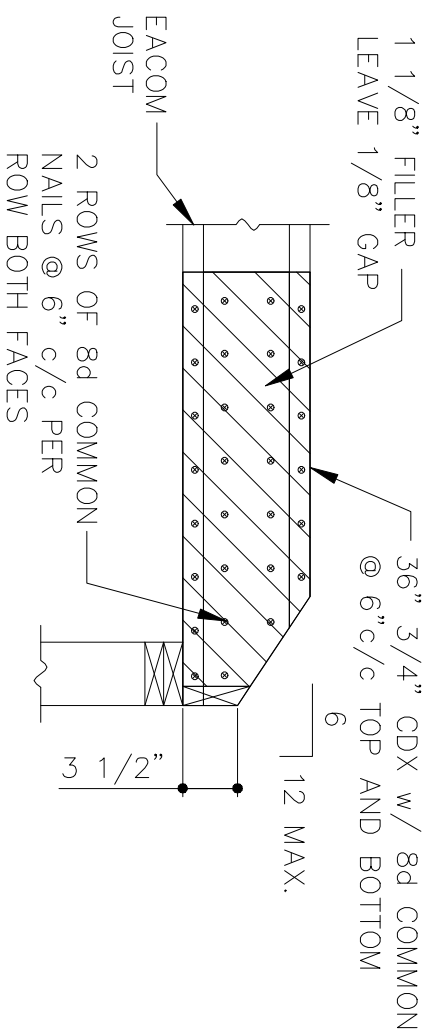
ALL GLUED AND NAILED

NOTE:
DAMAGE TO I-JOIST FLANGE
AND/OR WEB CAN CAUSE
FAILURE OF FLOOR SYSTEM.
SPAN, SPACING AND LOADING AS
WELL AS EXTENT AND LOCATION
OF DAMAGE ALL AFFECT THE
REPAIR REQUIRED.
EACH CASE SHALL BE REVIEWED.
