TYPICAL REPAIR DETAIL "E"

P3 BY EACOM
 TYPICAL REPAIR DETAILS

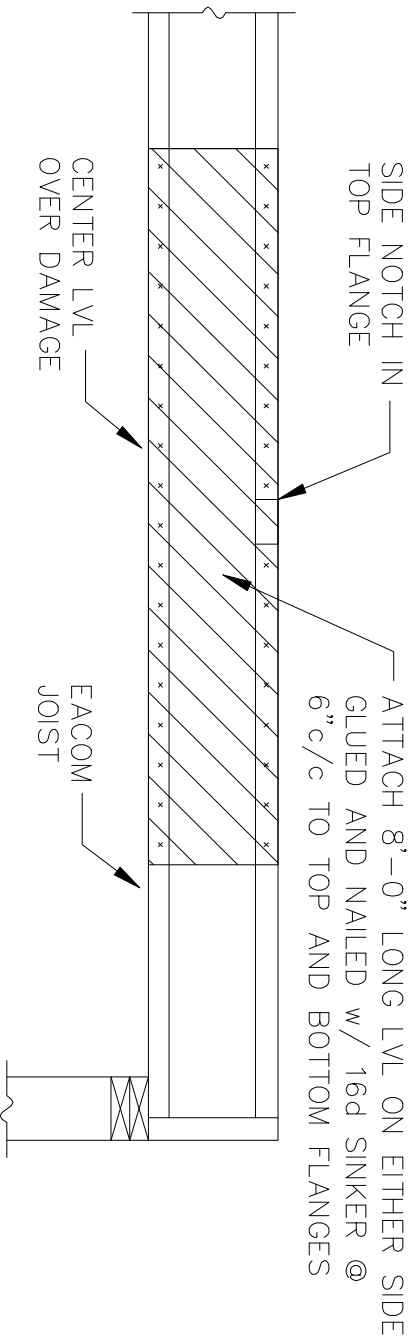
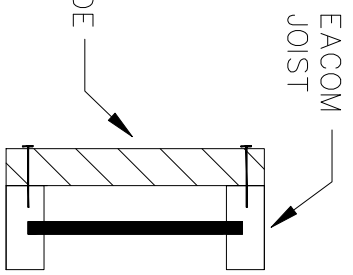
ALL GLUED AND NAILED

REPAIR DETAIL FOR TOP FLANGE NOTC, 50% DAMAGE TO FLANGE, AT CENTER SPAN OF JOISTS

ATTACH 8'-0" LONG LVL ON EITHER SIDE GLUED AND NAILED w/ 16d SINKER @ 6" c/c TO TOP AND BOTTOM FLANGES

NOTE:
 DAMAGE TO I-JOIST FLANGE AND/OR WEB CAN CAUSE FAILURE OF FLOOR SYSTEM. SPAN, SPACING AND LOADING AS WELL AS EXTENT AND LOCATION OF DAMAGE ALL AFFECT THE REPAIR REQUIRED.
 EACH CASE SHALL BE REVIEWED.
