P3 BY EACOM
TYPICAL REPAIR DETAILS

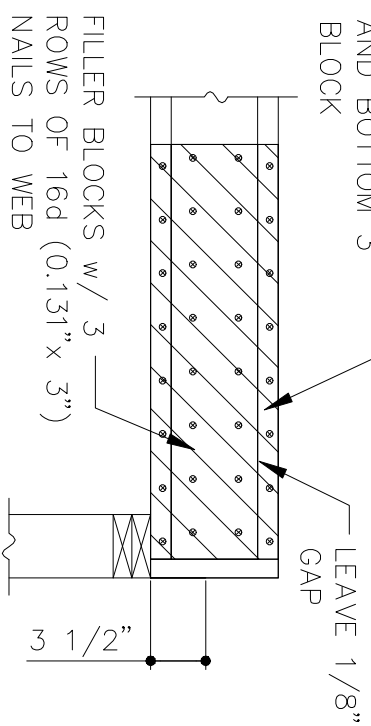
REPAIR DETAIL FOR LARGE
HOLE IN WEB NEAR
BEARING

24" 23/32 APA RATED SHEATHING BOTH SIDES
w/ 8d COMMON @ 6" c/c TOP AND BOTTOM 3
ROWS 16d @ 6" c/c TO FILLER BLOCK

ALL GLUED AND NAILED

NOTE:
DAMAGE TO I-JOIST FLANGE
AND/OR WEB CAN CAUSE
FAILURE OF FLOOR SYSTEM.
SPAN, SPACING AND LOADING AS
WELL AS EXTENT AND LOCATION
OF DAMAGE ALL AFFECT THE
REPAIR REQUIRED.

EACH CASE SHALL BE REVIEWED.
