Barrette Structural Inc.

## TYPICAL REPAIR METHOD FOR A CUT DIAGONAL WEB MEMBER NO PIPE

RTF-002-18

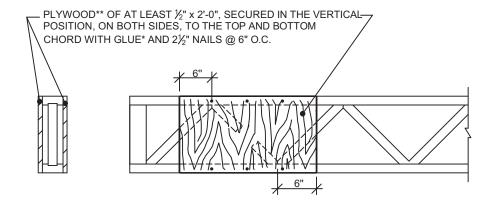
## SITUATION BEFORE REPAIR

## SITUATION AFTER REPAIR

\*PL PREMIUM GLUE

\*\* Plywood - at least ½" 4 ply (15/32") or better

This detail drawing is valid for uniform residential loads.
