## TYPICAL REPAIR METHOD FOR A CUT 2x3 OR 2x4 TOP CHORD

RTF-005-18

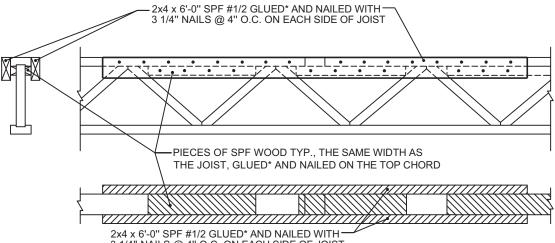
## SITUATION BEFORE REPAIR

## SITUATION AFTER REPAIR

2x4 x 6'-0" SPF #1/2 GLUED\* AND NAILED WITH- 3 1/4" NAILS @ 4" O.C. ON EACH SIDE OF JOIST

\*PL PREMIUM GLUE
